# Fungal contamination in a university archive: an aeromycological approach

### Museum archive of DISTAV at UniGe;

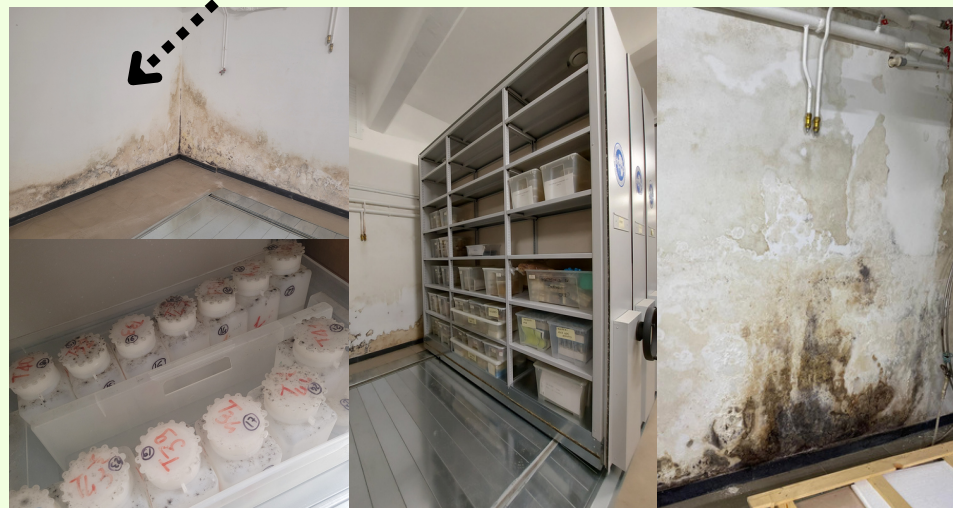
Signs of fungal contamination on walls and compactor covers present for the preservation of archival material

Photographs of the sampled room and objects showing clear signs of fungal contamination.

Interventions are necessary, including environmental remediation, reconditioning of the ventilation system, and continuous monitoring

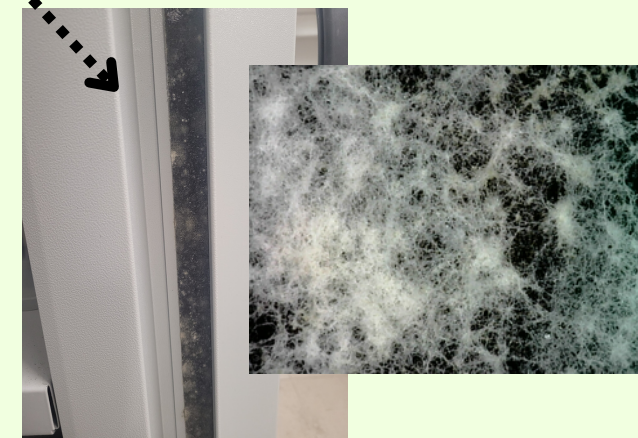
Visible fungal contamination on the compactor sheaths

The degradation of the compactor sheaths correlates with the colonization by *Penicillium citrinum* and *P. chrysogenum*.
