# Fungal contamination in a university archive: an aeromycological approach

### Museum archive of DISTAV at UniGe;

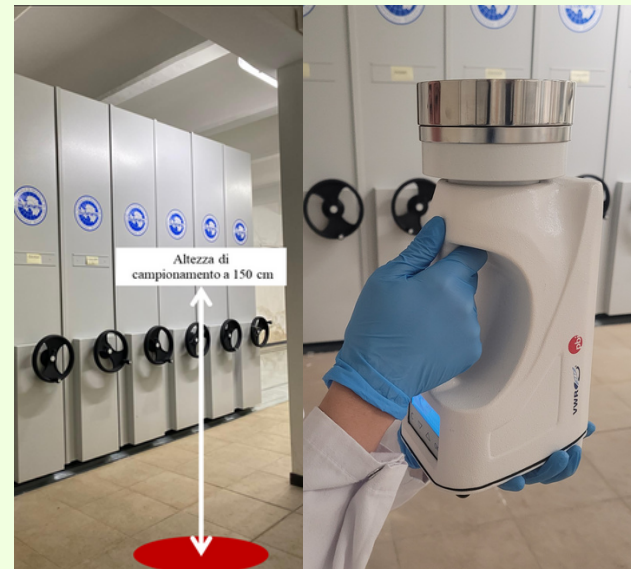
Sampling operations using the Surface Air System instrument.

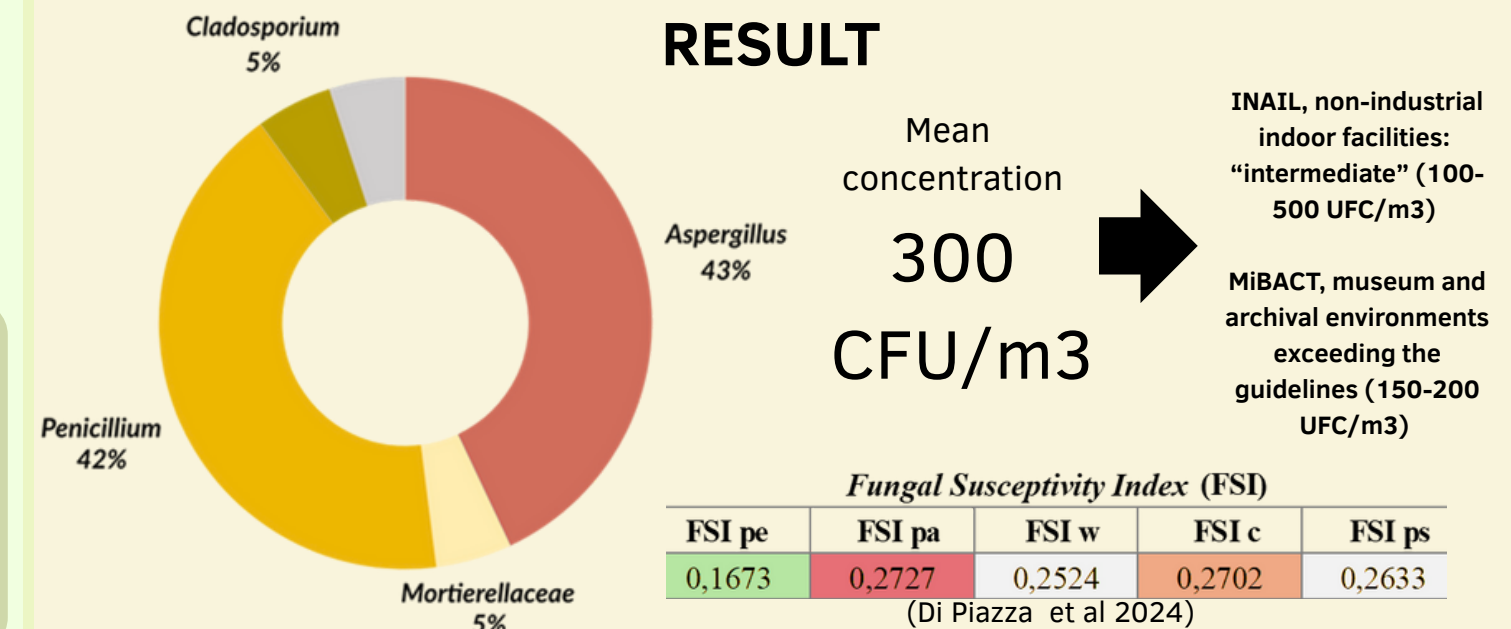
The mean concentration falls within the intermediate range according to INAIL, but exceeds the MiBACT recommended thresholds

The biological hazard is minimal, chiefly linked to *Aspergillus creber* and members of the Mucorales order

The degradation of the compactor sheaths correlates with the colonization by *Penicillium citrinum* and *P. chrysogenum*.

The biodeterioration of paper-based materials and plaster poses a primary concern, driven by the activity of *Penicillium* and *Aspergillus* species
